Manhole Inspection Summary

Manhole # S31II1001MH

Insp Date: **3/20/07 12:48 PM**

Location Address: **200 RIDGEMEDE RD**

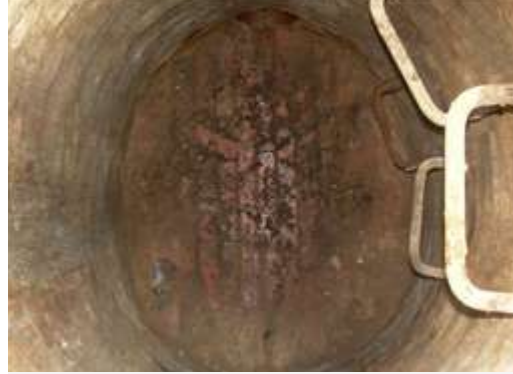
Top View

Channel Material: **Brick** ☐ Parged ☒ **Debris** (not Condition related)

Steps Count: **4** Missing: **0** ☒ **Corroded**

Corroded steps. Channel debris.

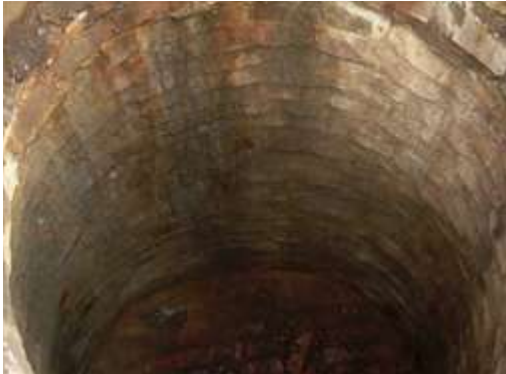
Defect

Condition: ☐ Sound ☐ Cracked ☐ Root Intrusion ☐ Loose Brick ☒ **Deteriorated**

Infiltration: ☐ None ☒ **Joint** ☐ Cracks ☐ Mortar ☐ Roots ☒ **Wall**

Infiltration: ☐ None ☐ Joint ☐ Cracks ☒ **Mortar** ☐ Roots ☒ **Wall**

Adjustment deterioration and infiltration.
Barrel infiltration.

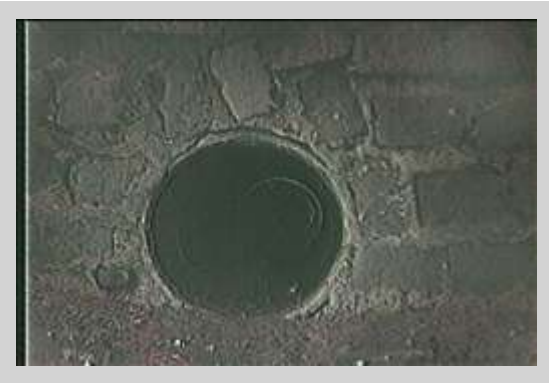
8 in. Circular Gravity Sewer Pipe Out @ 12 O'Clock

Infiltration: **Evidence** Pipe Seal Cond: **Cracked**

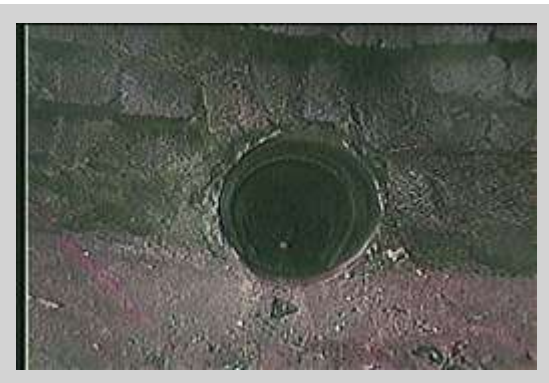
8 in. Circular Gravity Sewer Pipe In @ 6 O'Clock

Infiltration: **Evidence** Pipe Seal Cond: **Cracked**
